U.S. Department  
of Transportation

National Highway  
Traffic Safety  
Administration

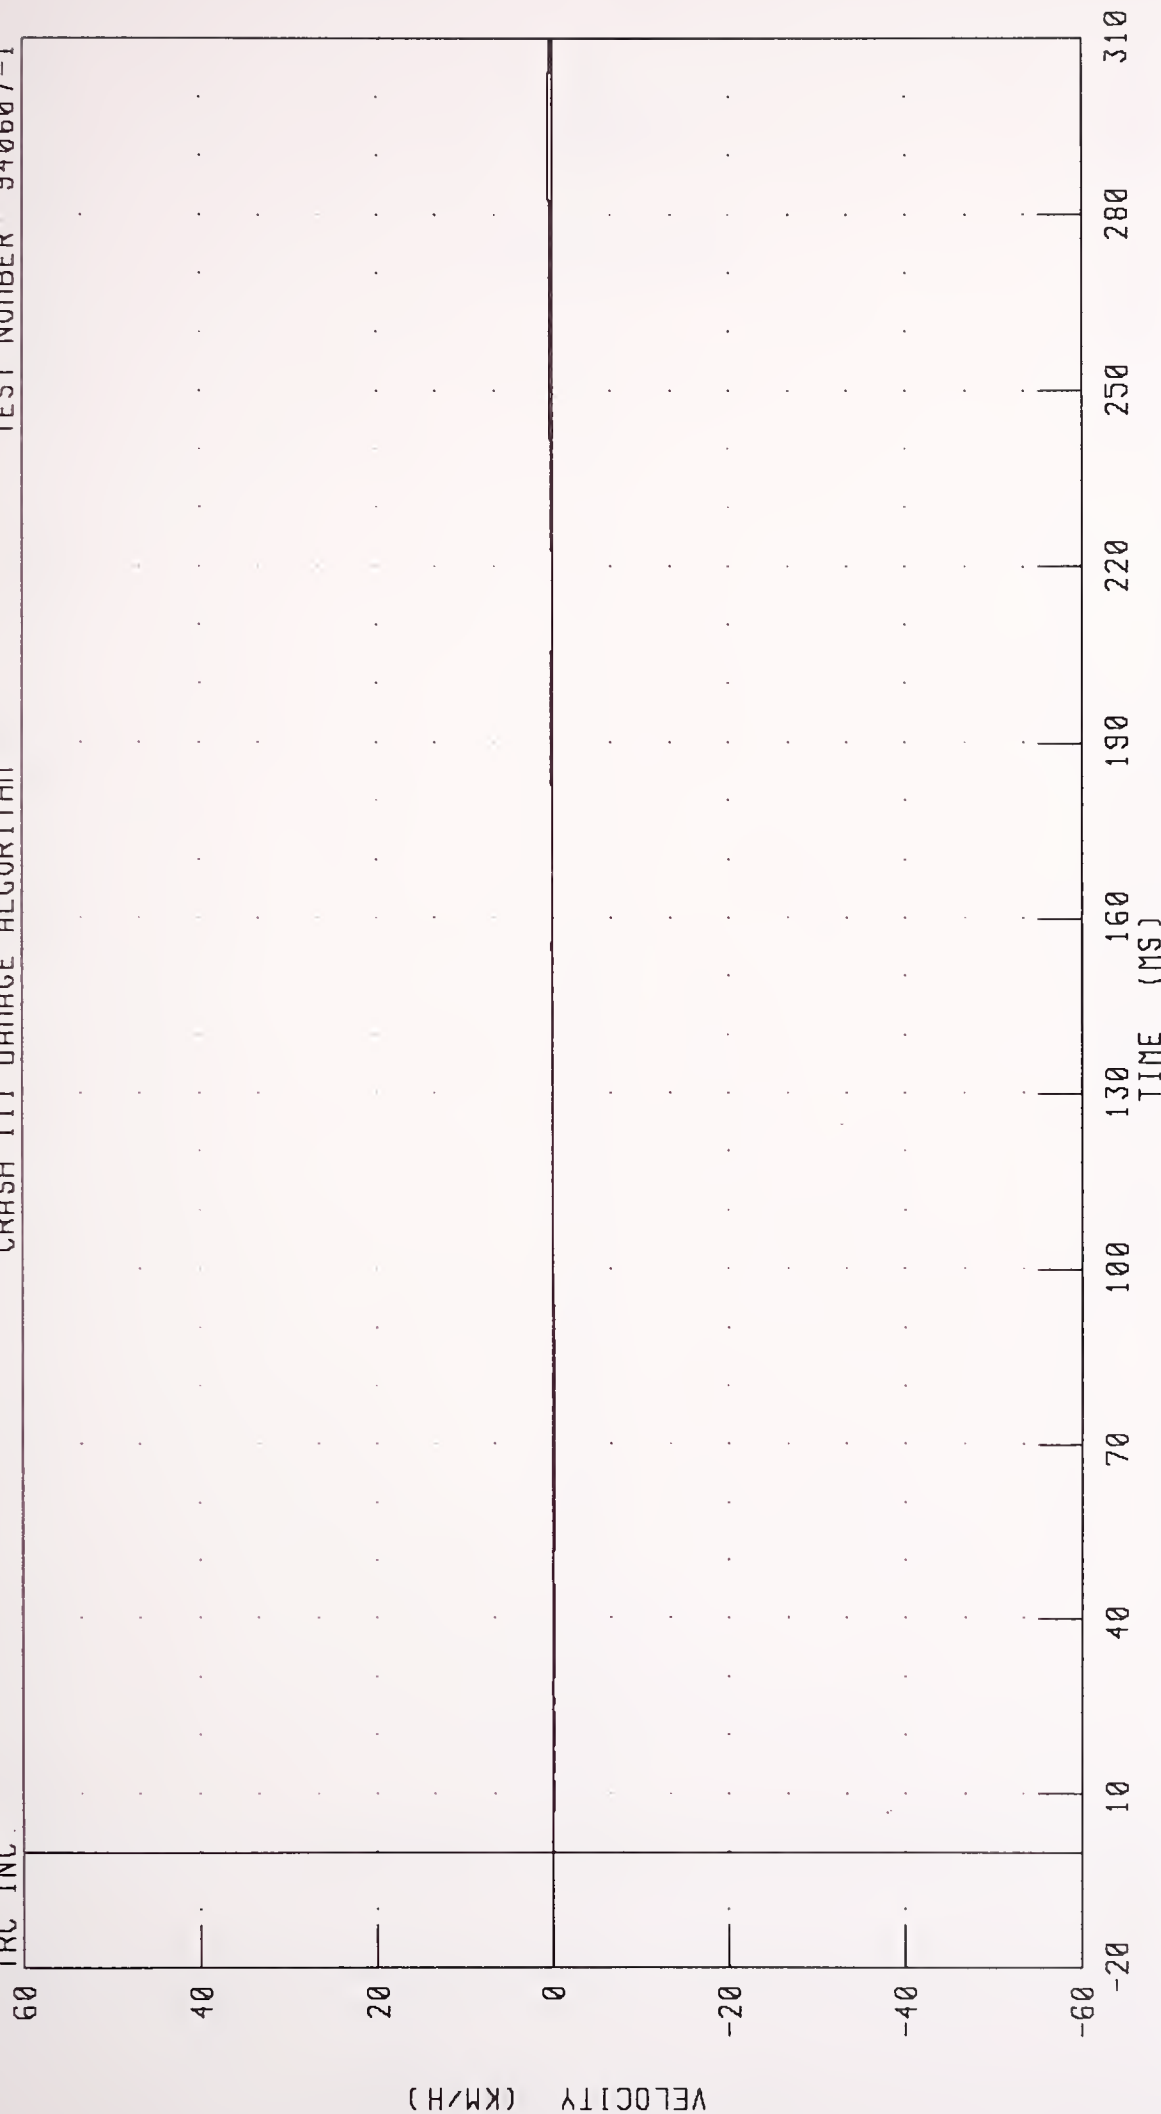
CHANNEL: RRSYV1 FILTER: CH. CLASS 180 PEAK DATA: 0.47 KM/H @ 288.40 MS; -0.16 KM/H @ 74.48 MS

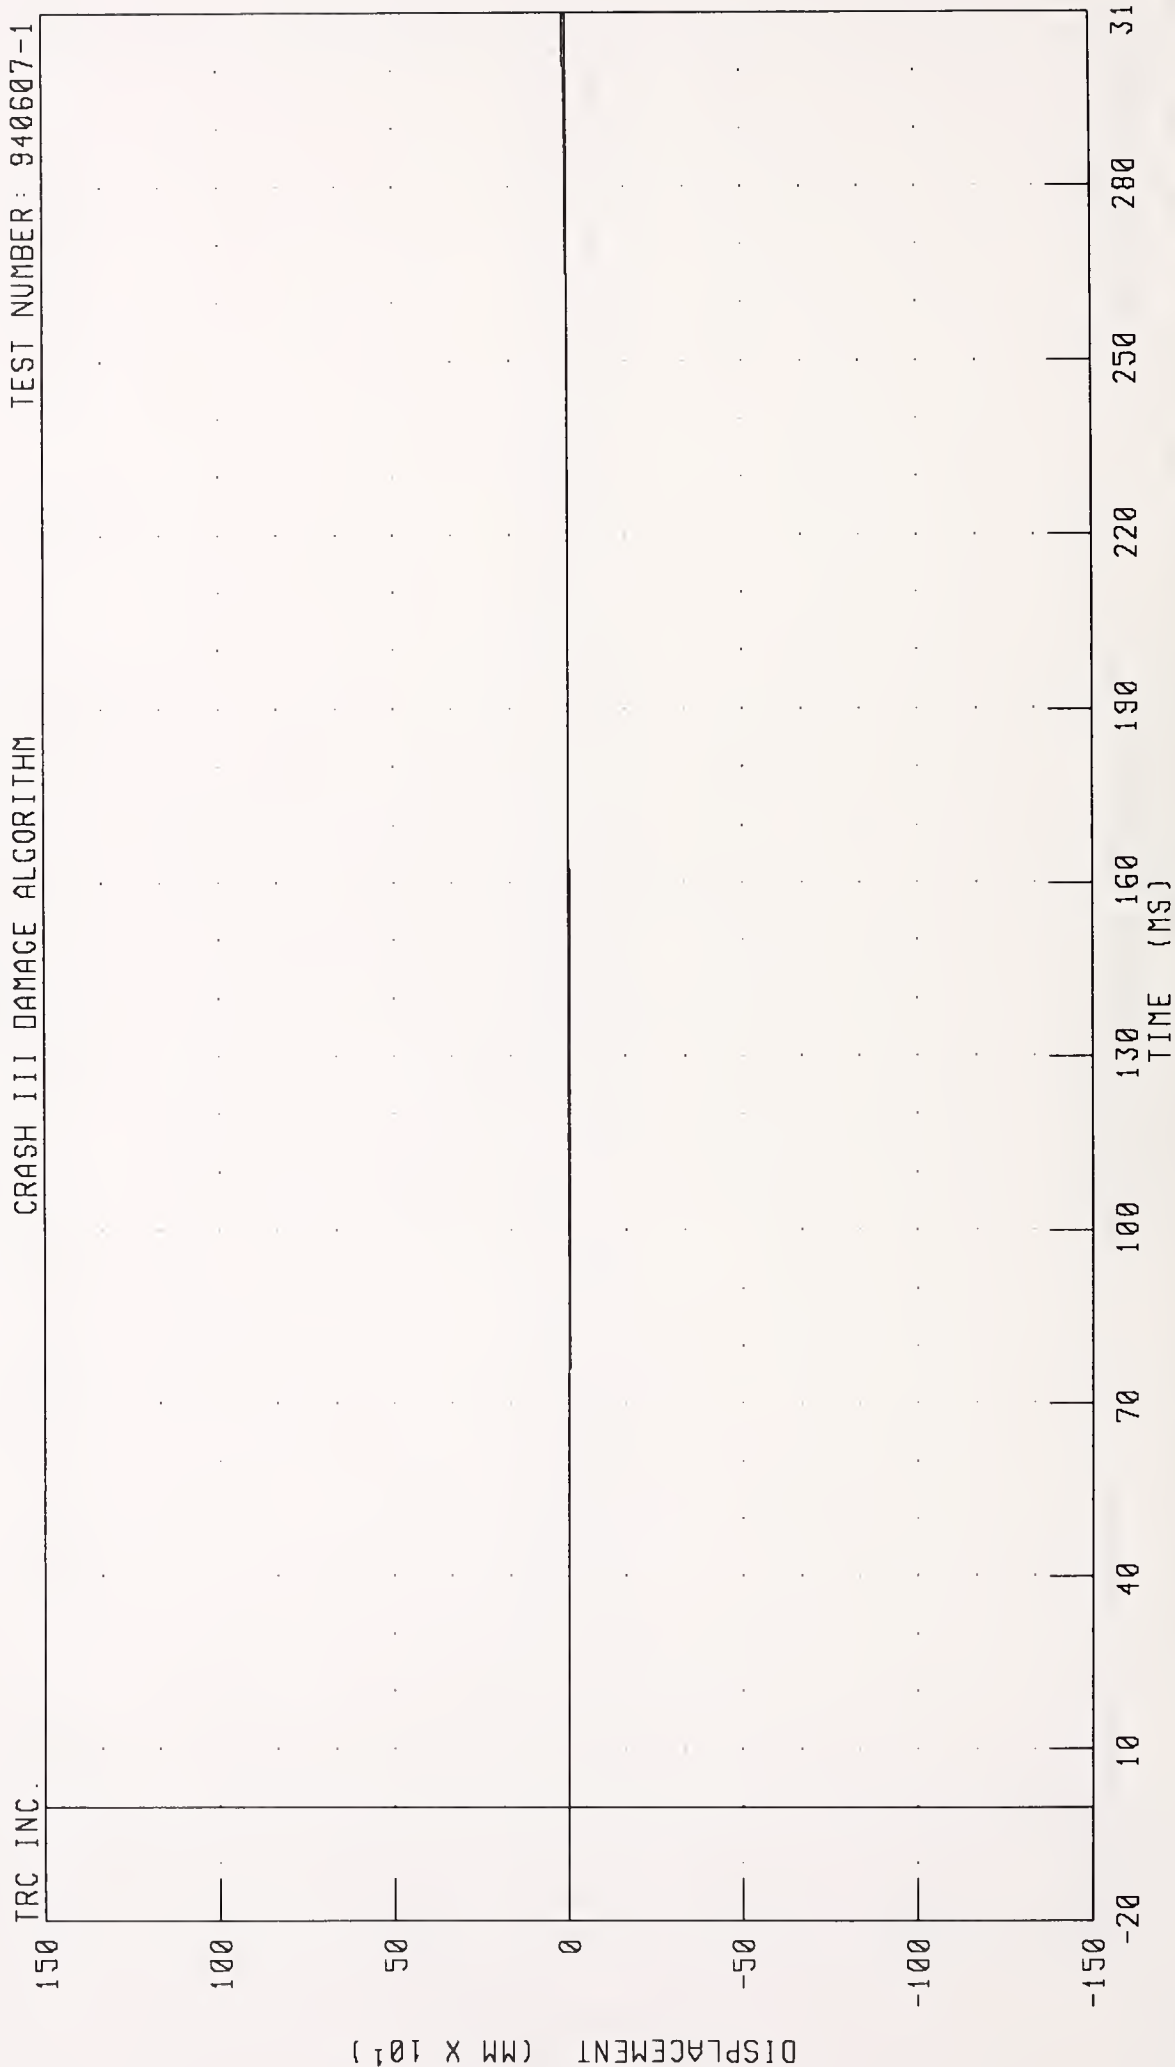
CHANNEL: RRSYD1 FILTER: CH. CLASS 180

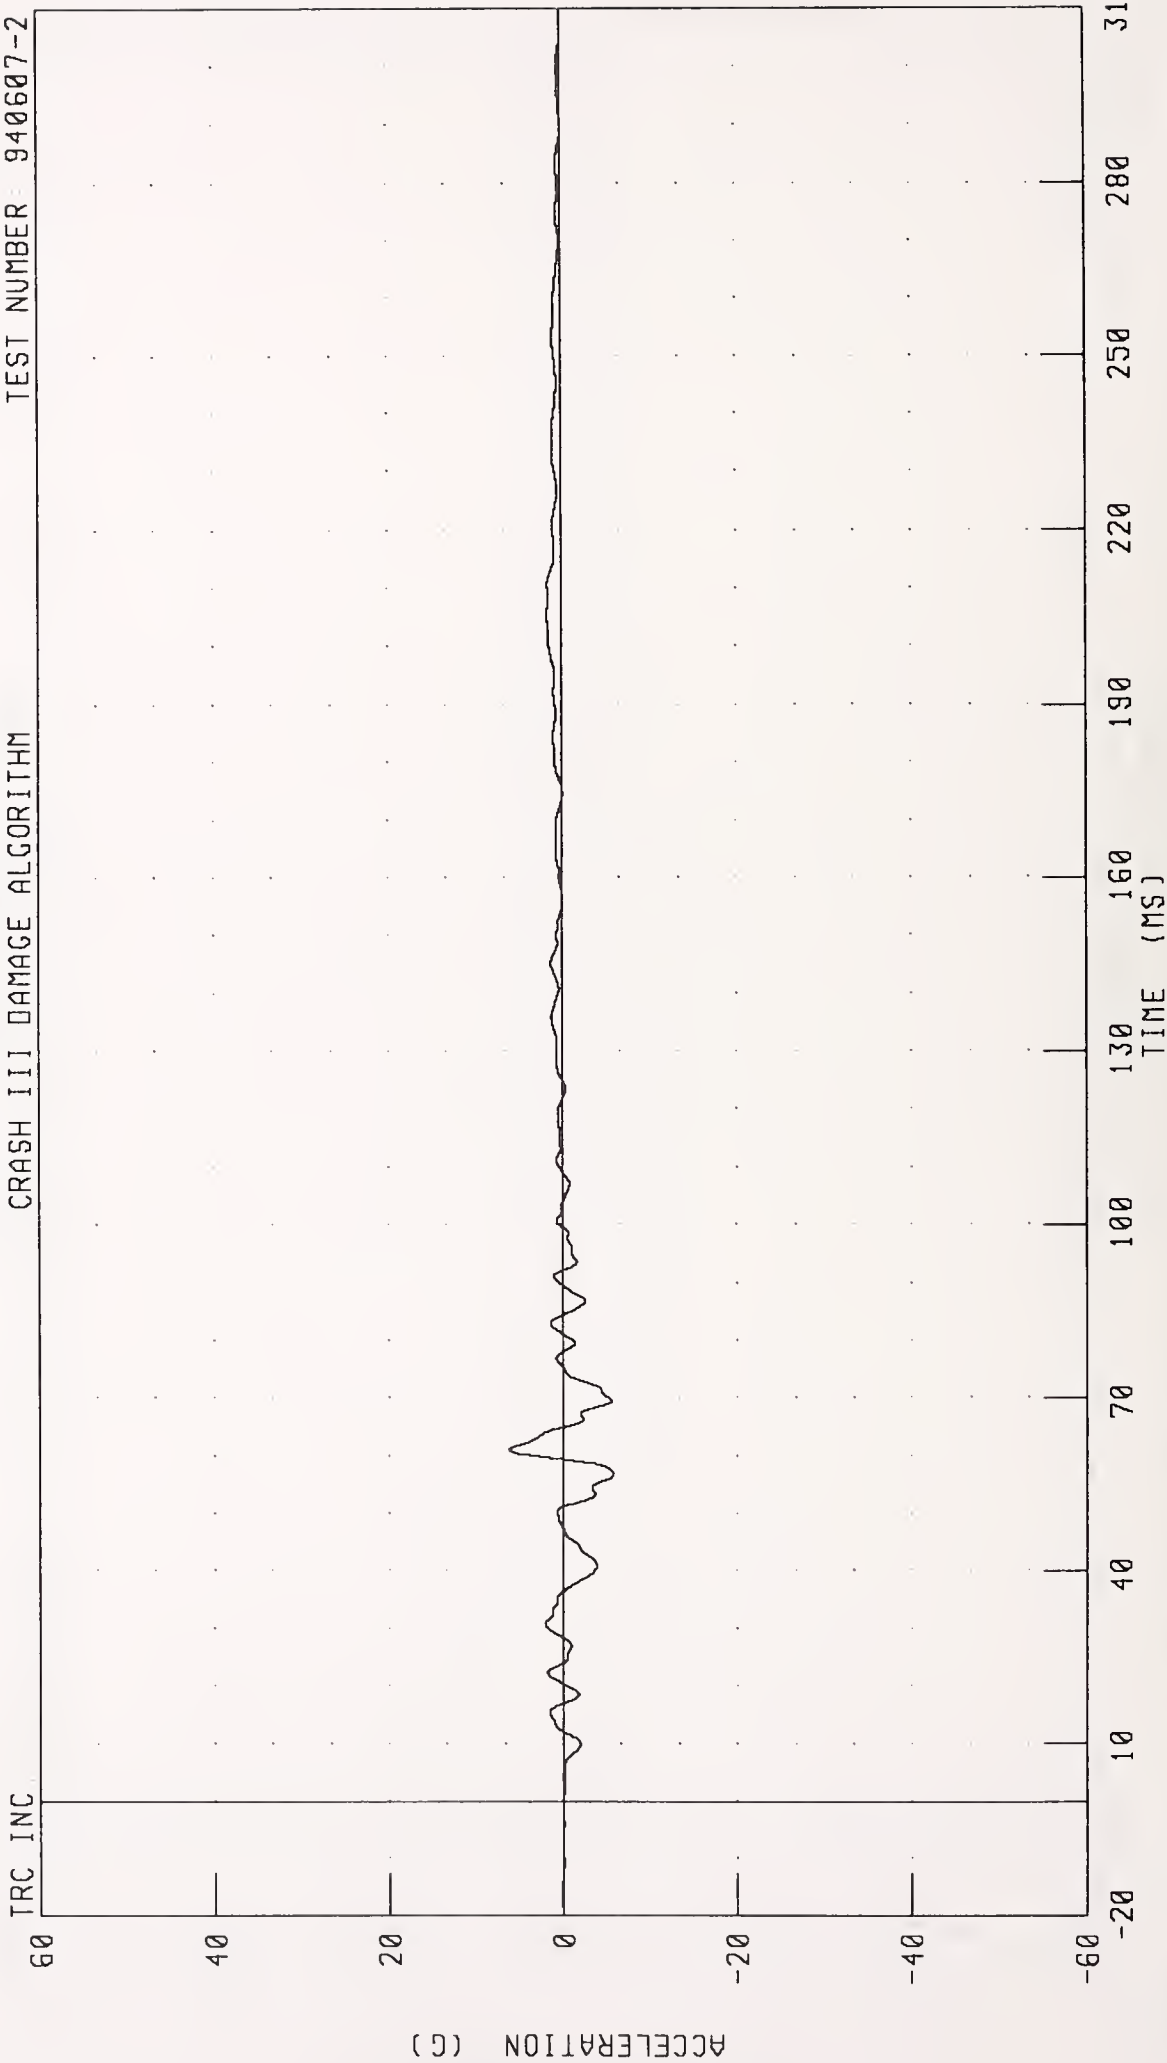
CHANNEL: VCGYG1 FILTER: CH. CLASS 60

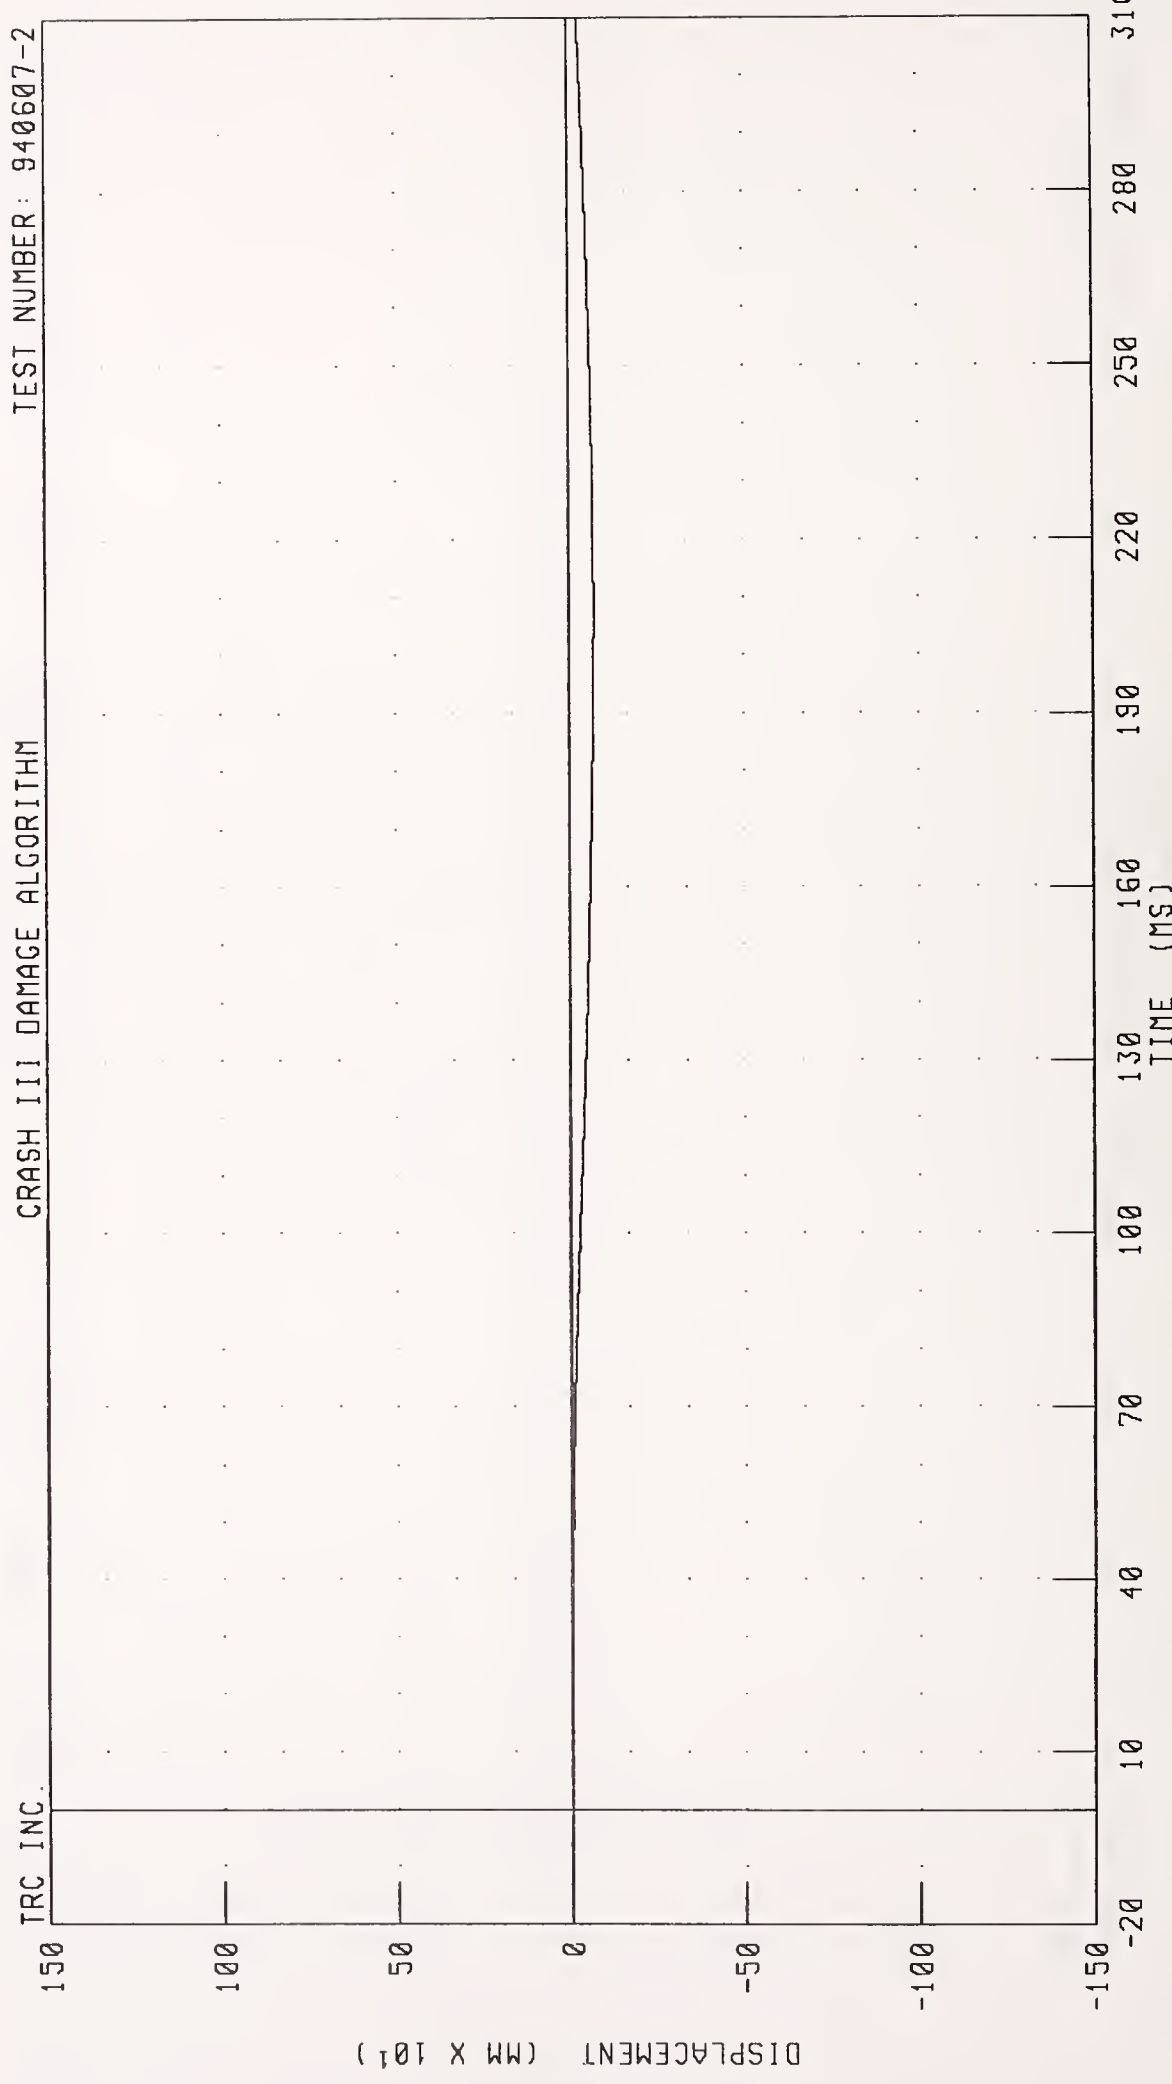
CHANNEL: VCGYD1 FILTER: CH. CLASS 180

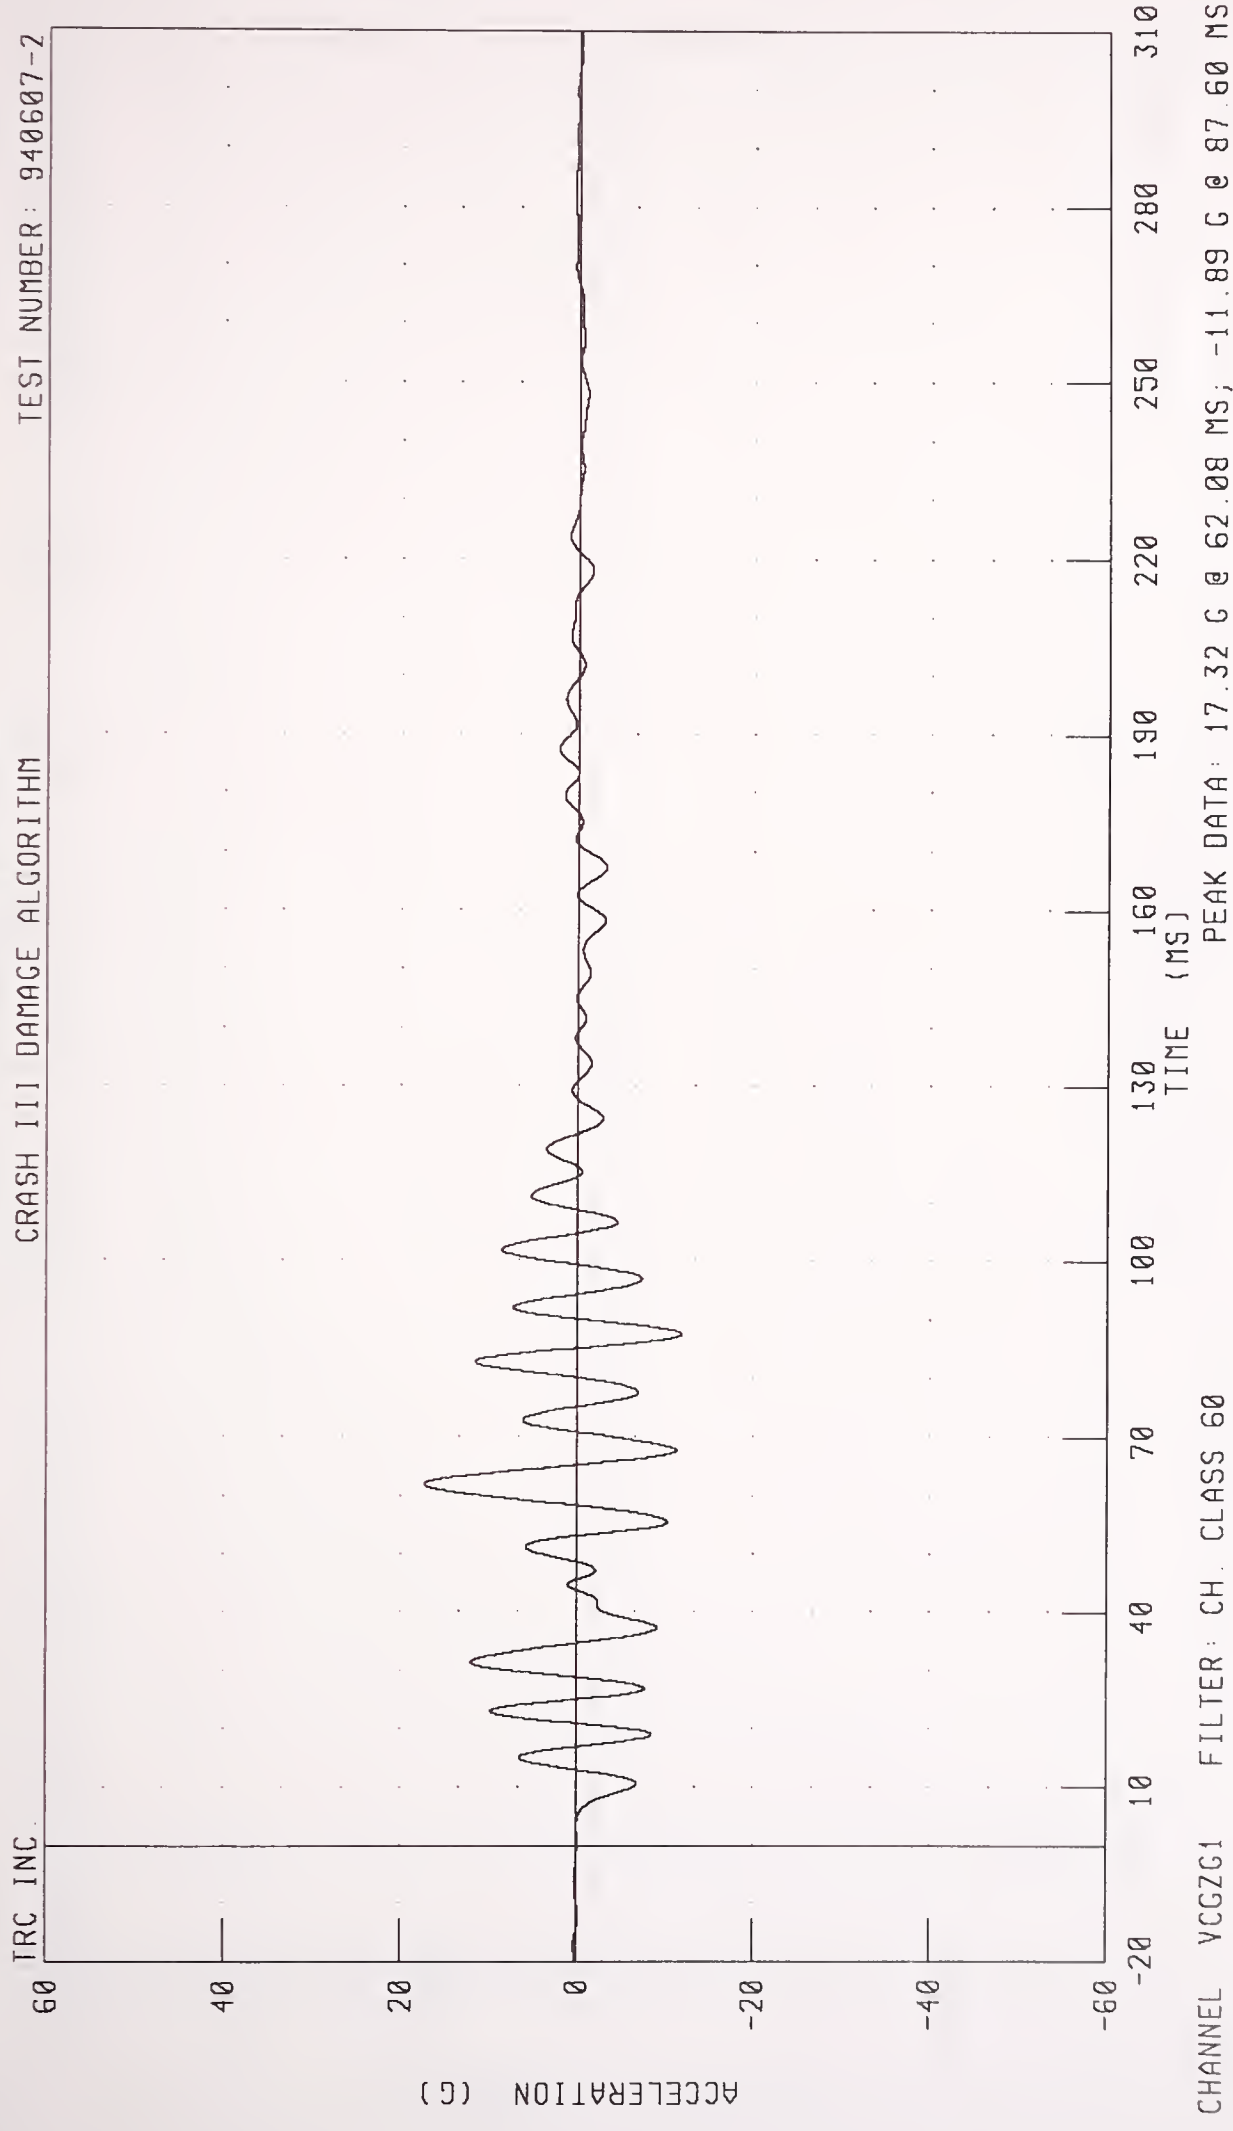
CHANNEL VCGZG1 FILTER: CH. CLASS 60

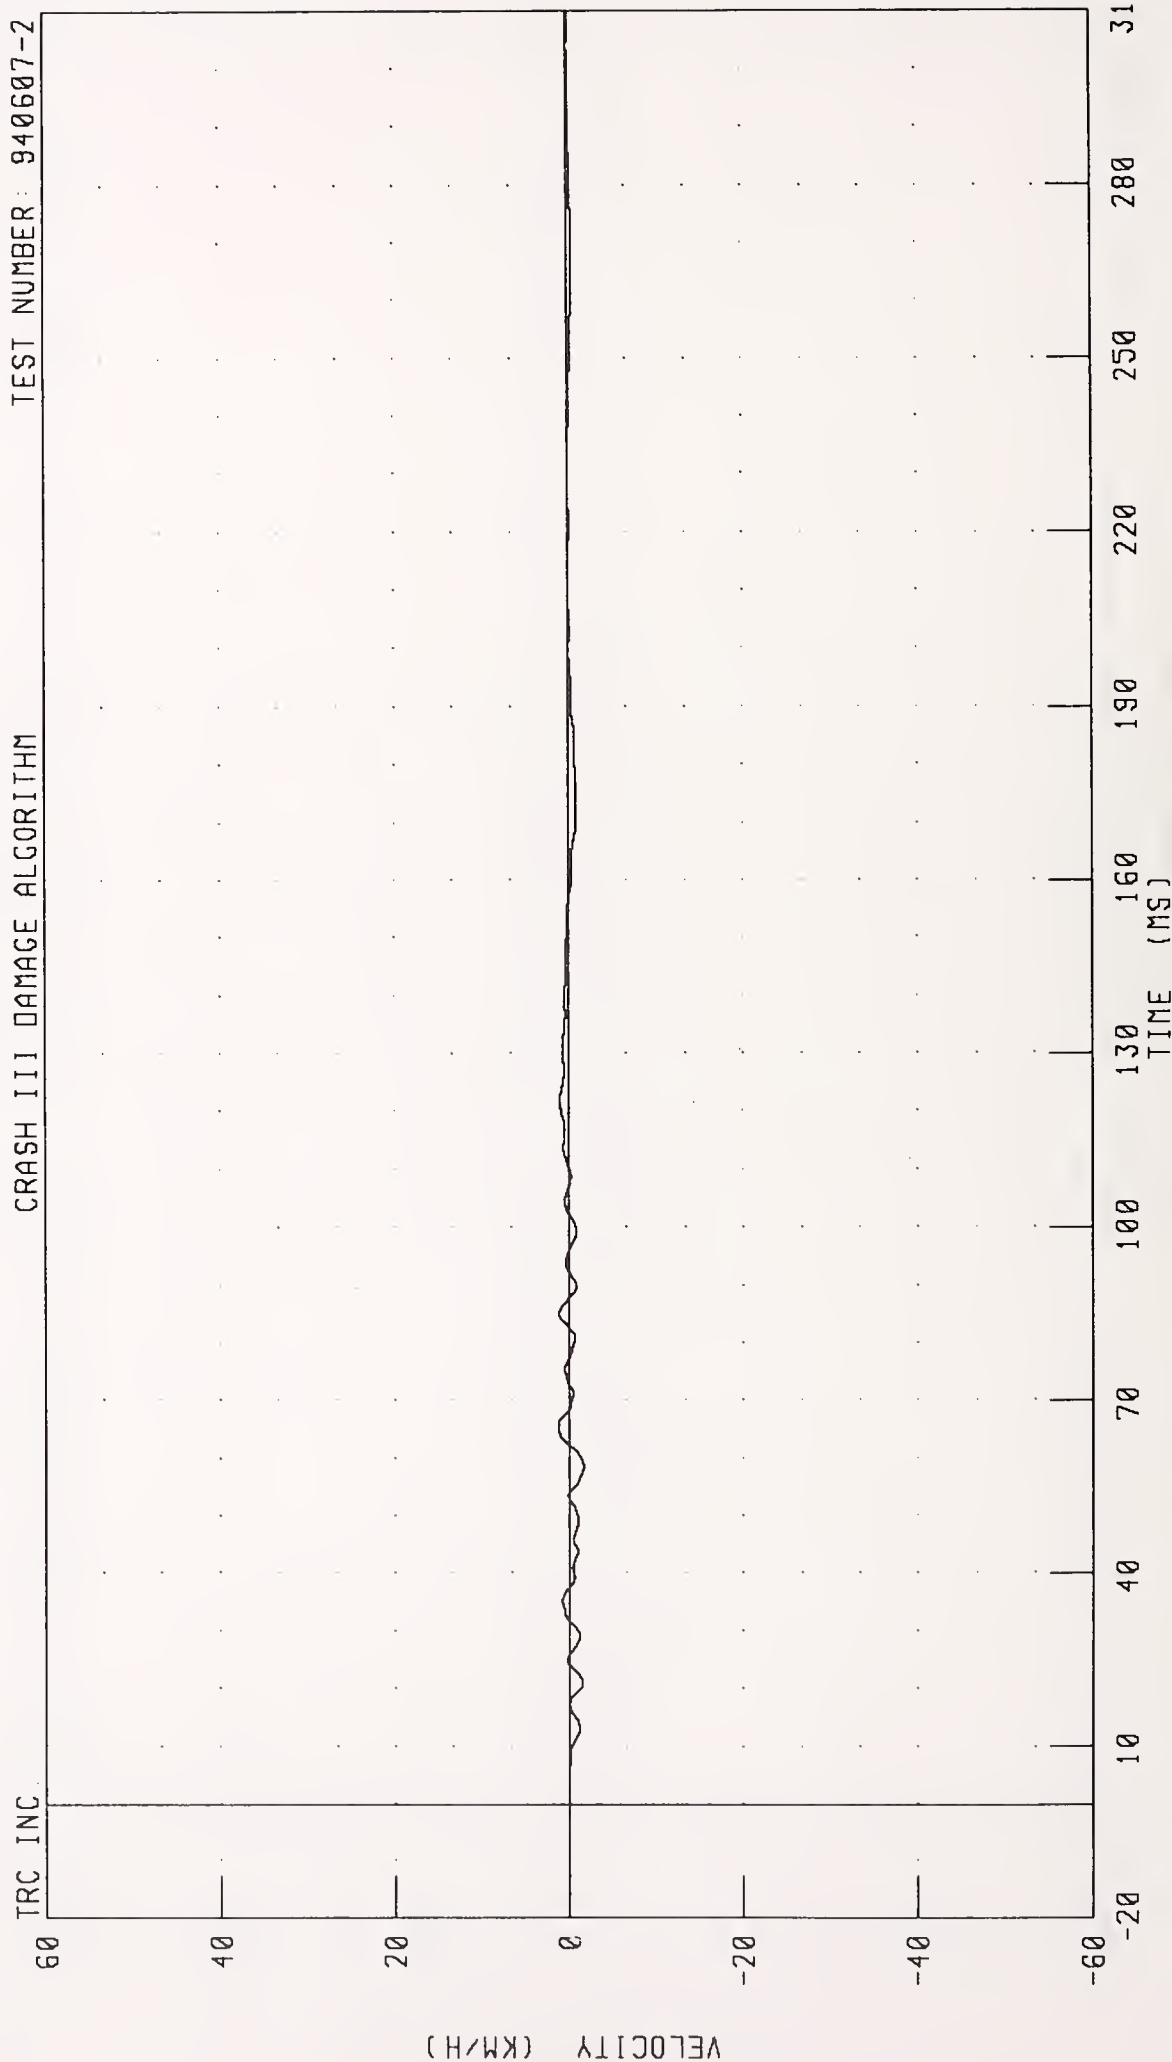
CHANNEL: VCGZV1 FILTER: CH. CLASS 180 PEAK DATA: 1.24 KM/H @ 66.00 MS; -1.64 KM/H @ 58.48 MS

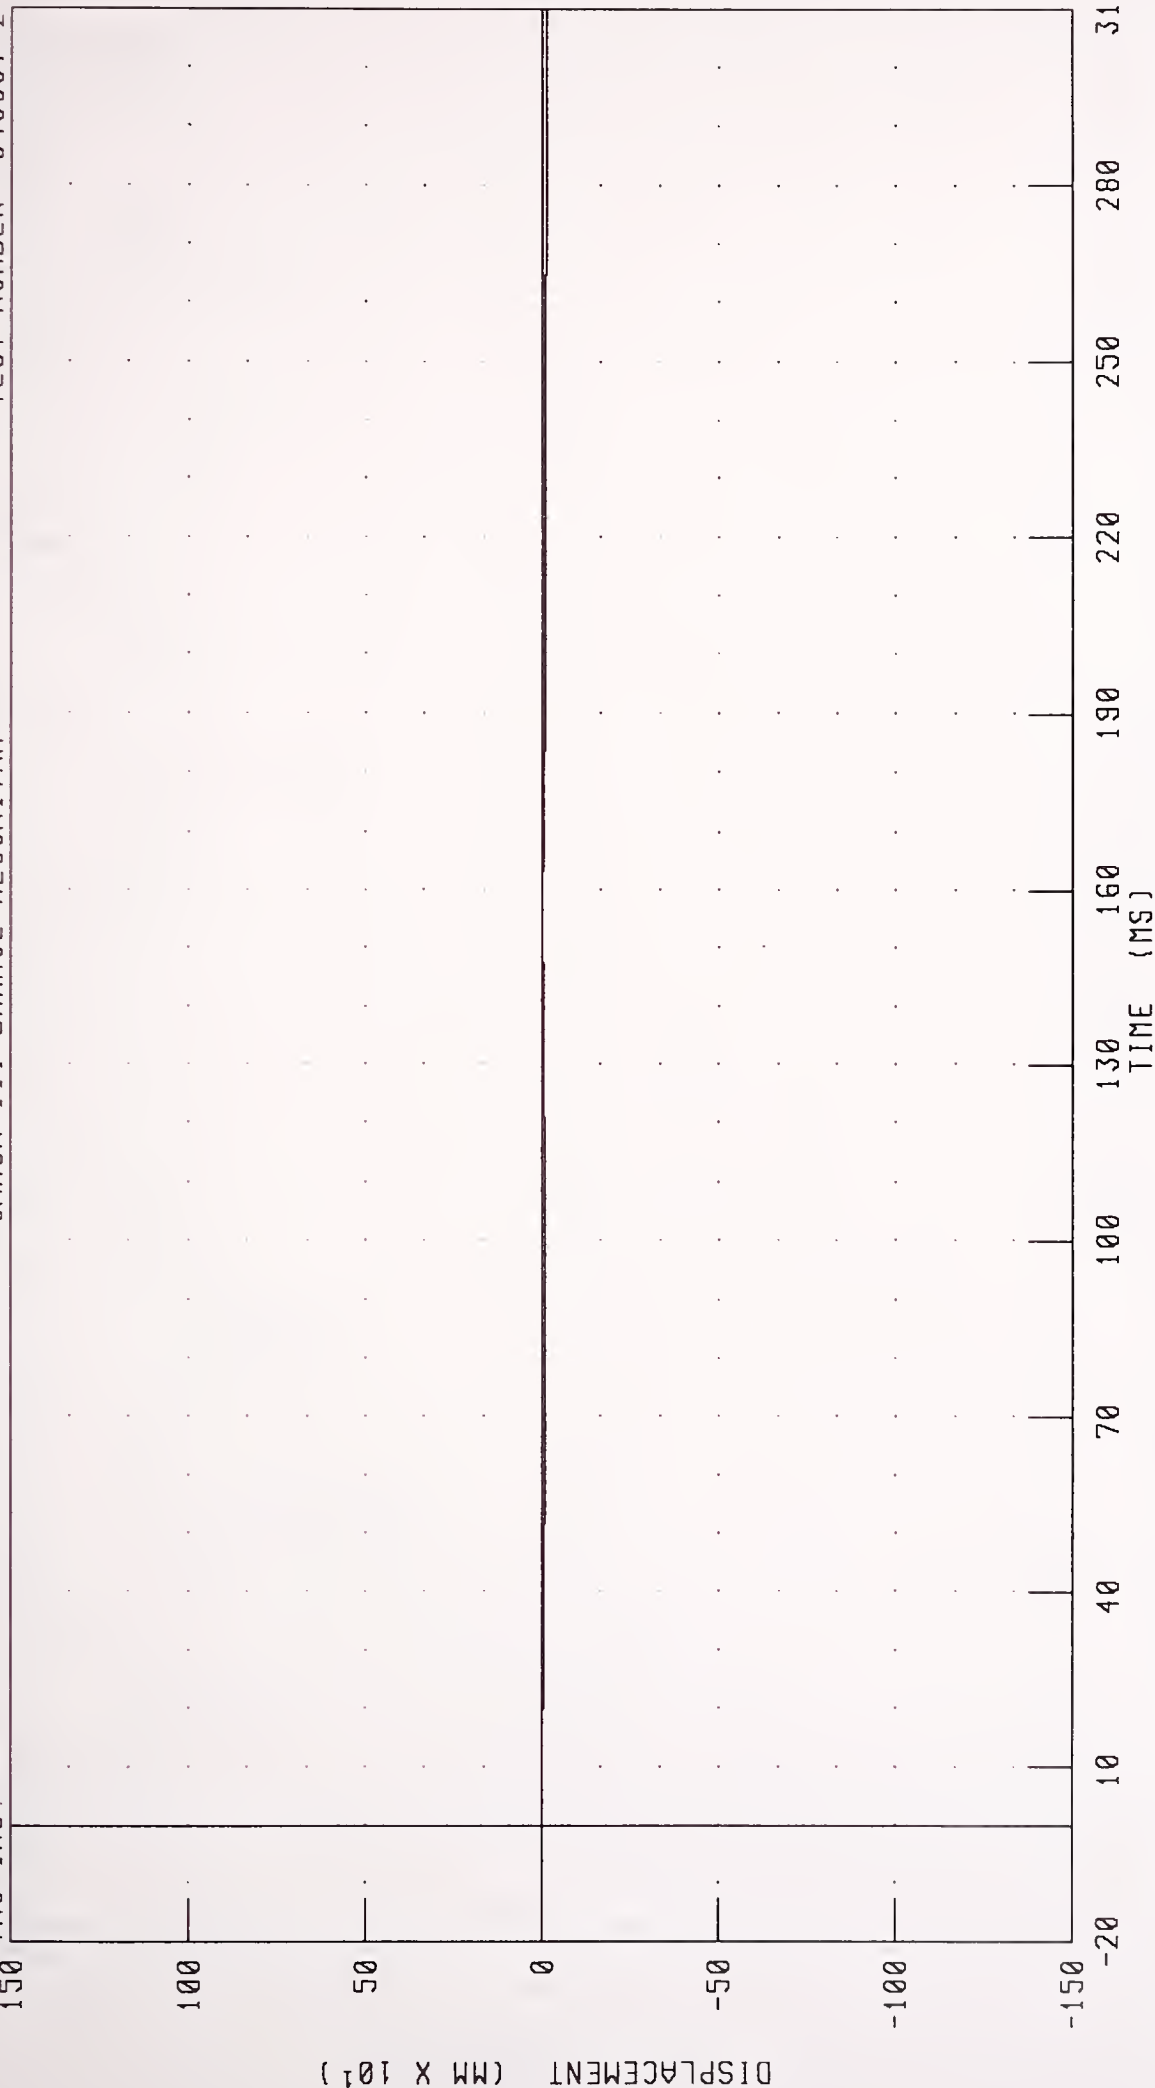
CHANNEL: VCGZ01 FILTER: CH. CLASS 180

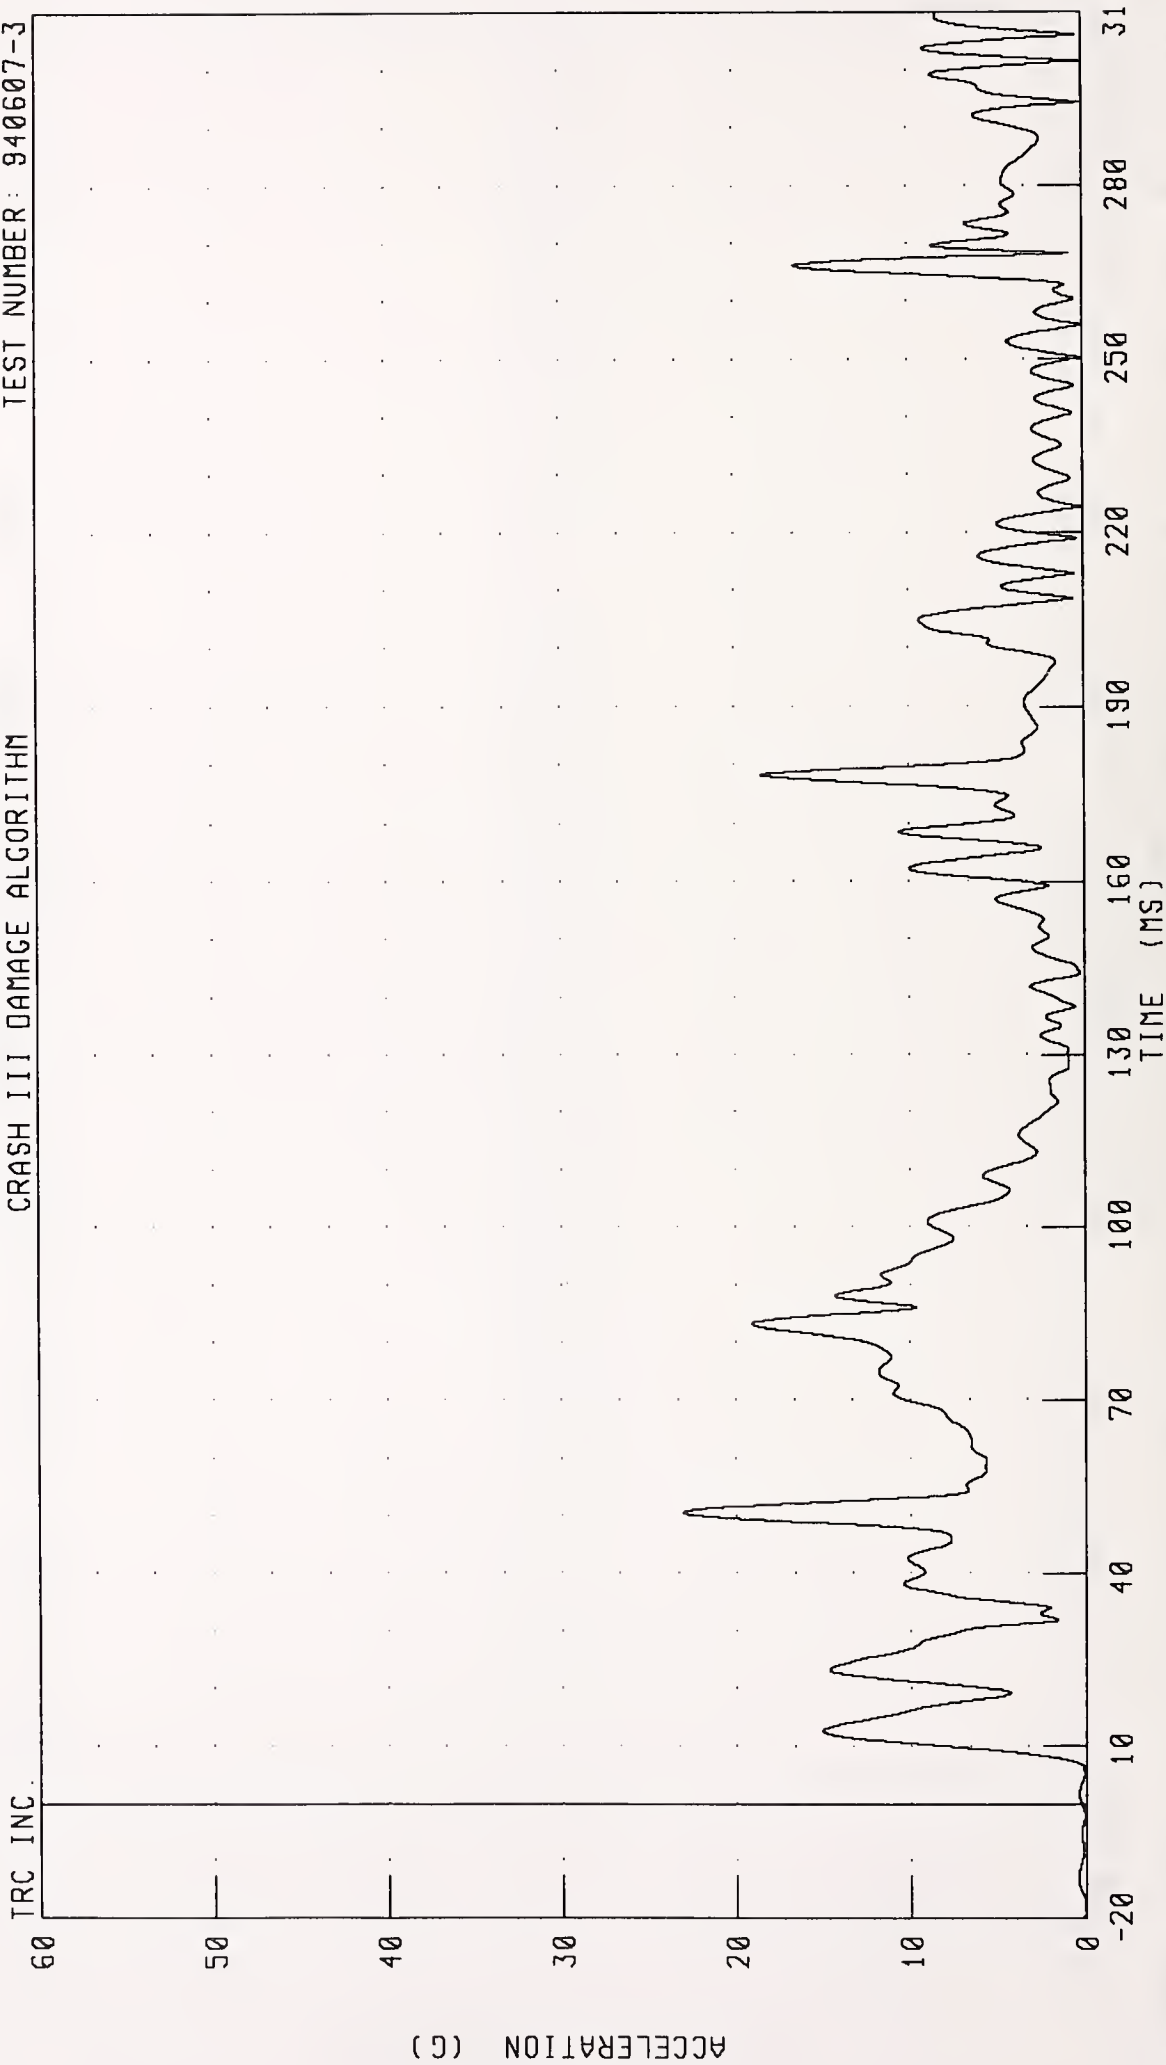
CHANNEL: VCGRG1 FILTER: CH. CLASS 60

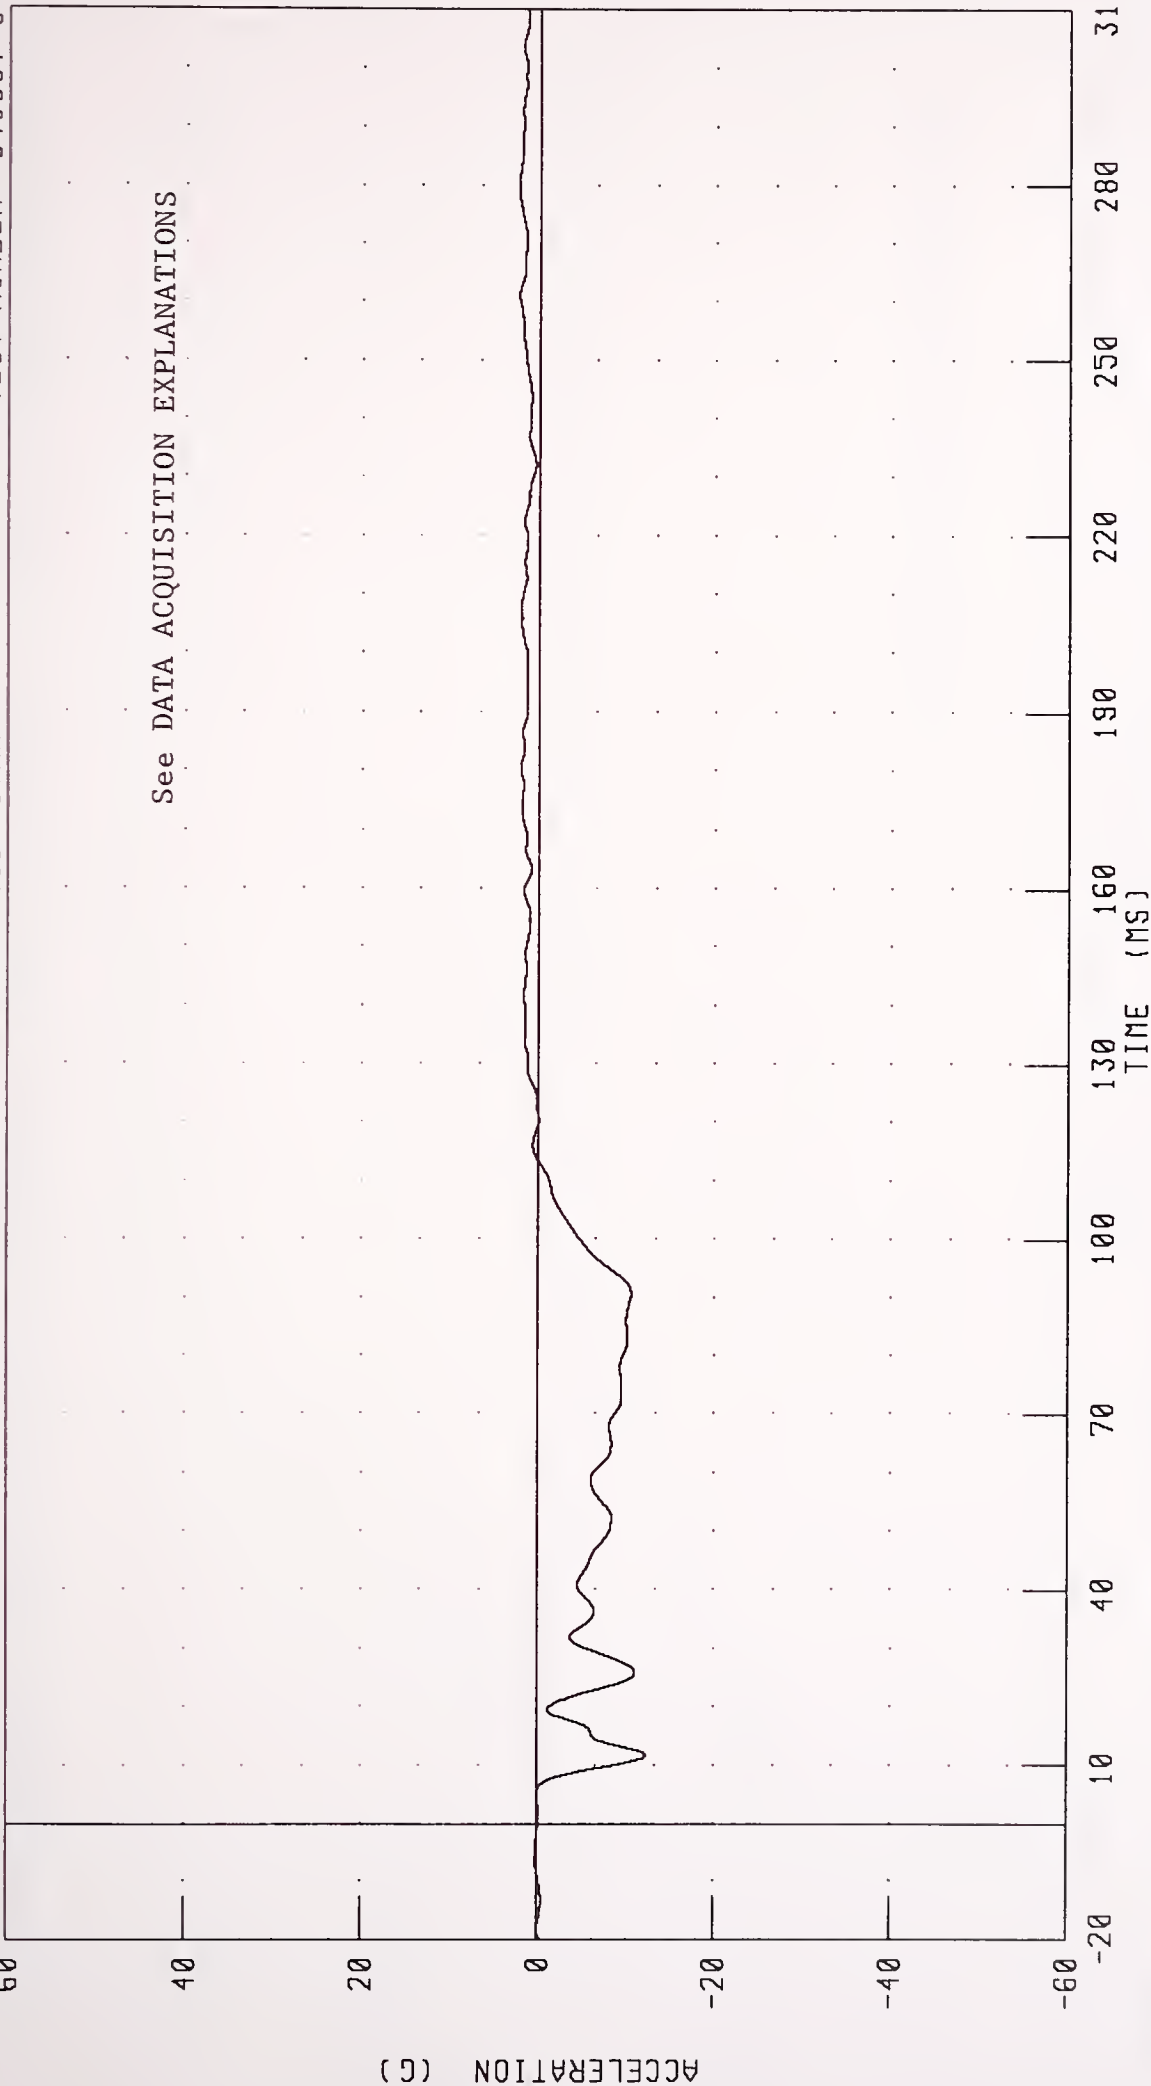
See DATA ACQUISITION EXPLANATIONS
